DEPARTMENT OF TRANSPORTATION

Quality Assurance and Source Inspection

Contract #: 04-0120F4Cty: SF/ALA Rte: 80 PM: 13.2/13.9File #: 69.28**WELDING INSPECTION REPORT****Resident Engineer:**Pursell, Gary**Address:** 333 Burma Road**City:** Oakland, CA 94607**Report No:** WIR-015501**Date Inspected:** 05-Jul-2010**Project Name:** SAS Superstructure**OSM Arrival Time:** 700**Prime Contractor:** American Bridge/Fluor Enterprises, a JV**OSM Departure Time:** 1900**Contractor:** Zhenhua Port Machinery Company, Ltd (ZPMC), Changxing Island **Location:** Shanghai, China**CWI Name:** Li Yang**CWI Present:** Yes No**Inspected CWI report:** Yes No N/A**Rod Oven in Use:** Yes No N/A**Electrode to specification:** Yes No N/A**Weld Procedures Followed:** Yes No N/A**Qualified Welders:** Yes No N/A**Verified Joint Fit-up:** Yes No N/A**Approved Drawings:** Yes No N/A**Approved WPS:** Yes No N/A**Delayed / Cancelled:** Yes No N/A**Bridge No:** 34-0006**Component:** OBG Segment**Summary of Items Observed:**

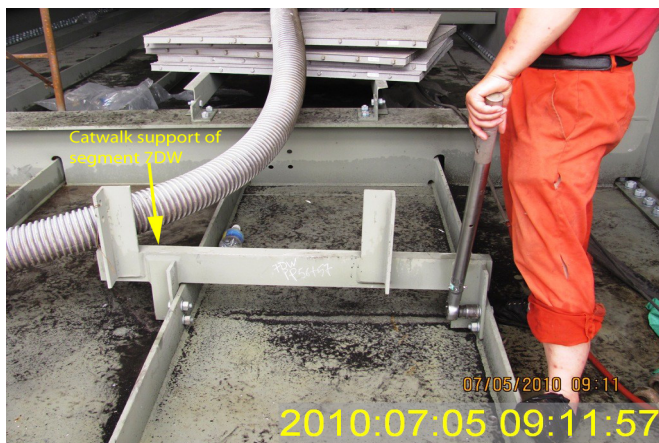
This QA inspector witnessed the final bolt tension verification on the Catwalk support of segment 7DW. The torque wrench S/N was 090001. The QA inspector witnessed 10% of the bolts on a random basis and found the tensioning of the bolts appeared to be in general compliance. The panel point and bolt size designations were as follows:
